## PRESS RELEASE RELATED ON THE TURVATIKAS-SAFETY LADDER PRODUCT NO 932

### Functionality of Climbing Carriage no. 932 must always be checked before use

### Instructions for checking wheels condition of the No 932 Climbing Carriage:

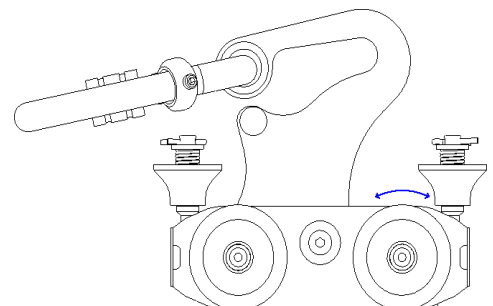
#### 2. The wheels must not rotate in relation to the shaft

- Catch the wheel by your hand and try to rotate the opposite wheel at same time.
- If the opposite wheel is rotating, the joint is loosened and the use of Climbing Carriage must be stopped immediately.

Nevertheless, the Climbing Carriage must always be checked before use and if there is any doubt about its condition or functionality, it must be disabled and its use must be prevented at least by clearly marking it and / or returning it to the Turvatikas-Safety Ladder.
